Guardian Housing Services Ltd

Job Ref: 4811

27th January 2023

RE: SAFE AND SANITARY REPORT, ALTERATIONS WITHIN THE BASEMENT AREA OF THE DWELLING AT 8 HAMILTON PLACE, GLENFIELD

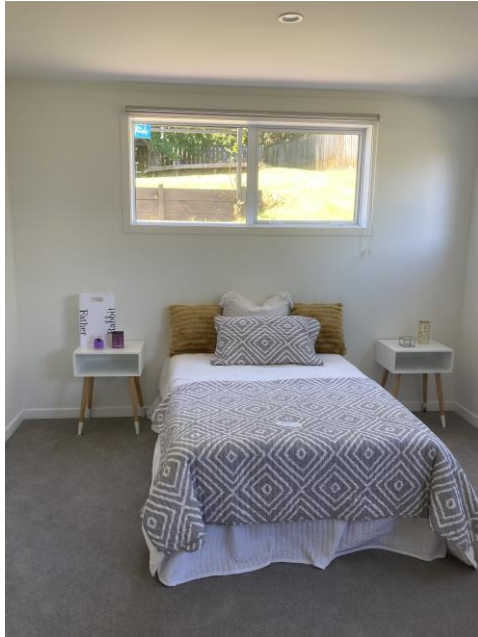
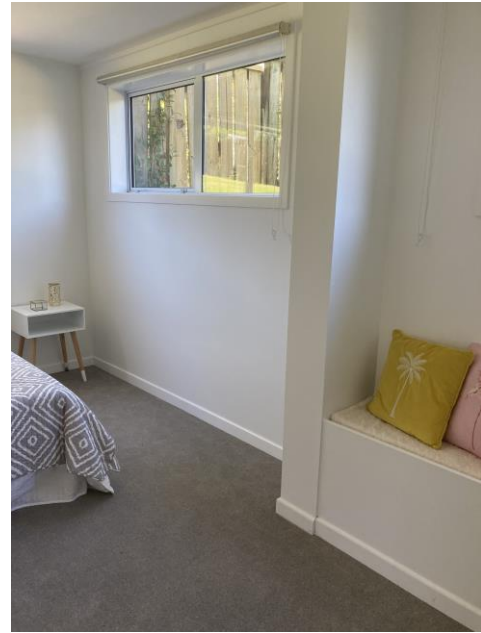
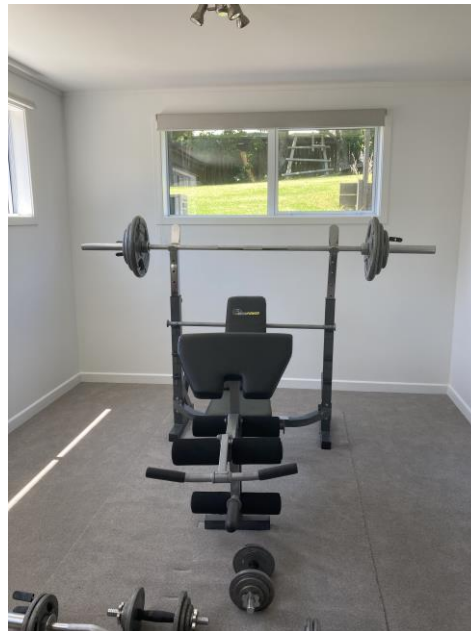
- 3.6 The rumpus and bedroom areas satisfy all the requirements considered as being necessary as habitable space. As a precautionary/maintenance measure a waterproofing application has been applied to the concrete floor area and this has been returned back up the concrete block walls

(strip of plaster board wall lining was removed around the perimeter) a floor leveling compound was also applied at the same time.

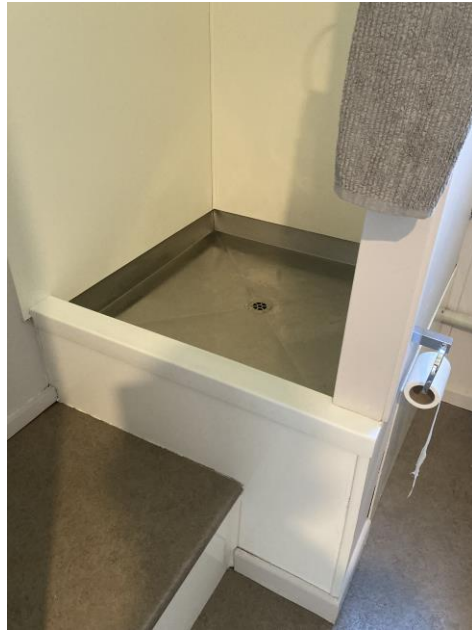
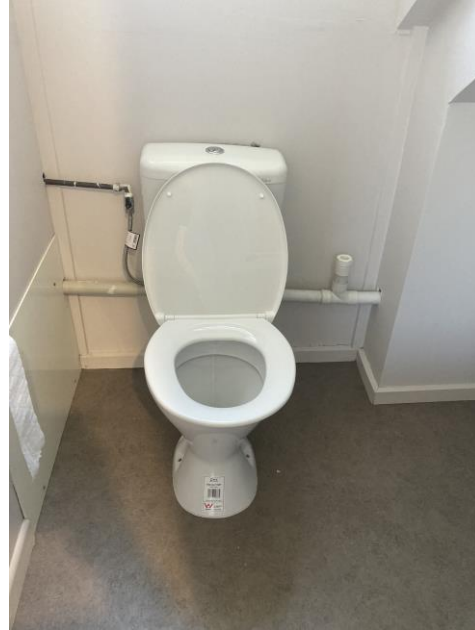
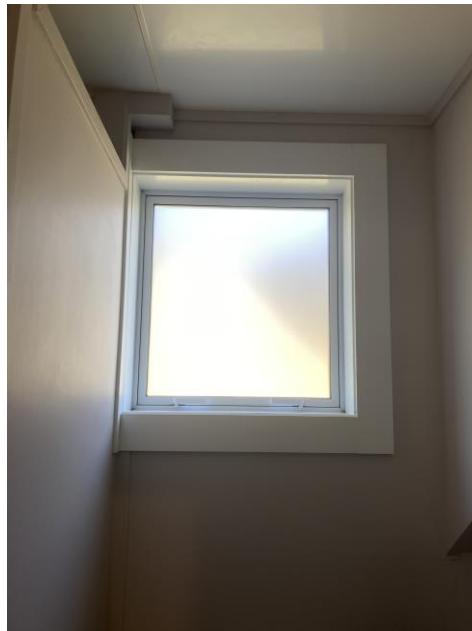
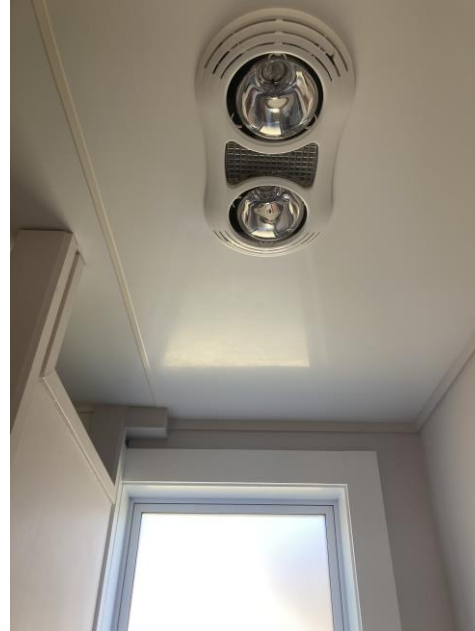
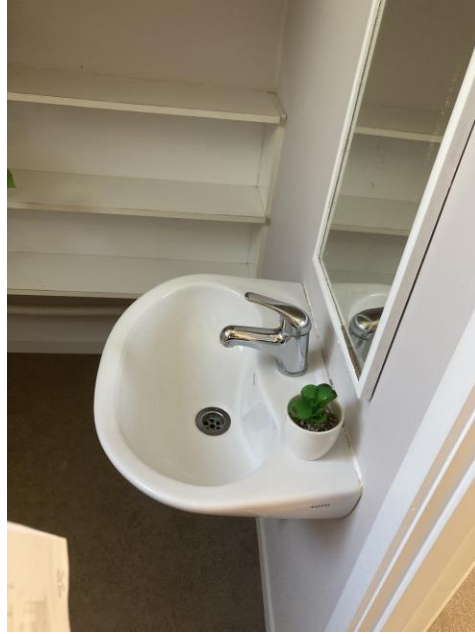
- 3.7 The bathroom consists of a shower unit (older style), vanity basin and a WC. There is a window within this area along with a mechanical extraction fan for ventilation. All surfaces are finished with impervious materials to resist moisture.

- 3.8 The plumbing installation was fully functional at the time of this assessment and there were no visual signs of system failure or leakage. The wastewater discharges to the preexisting gulley dish.
