Dear Sir

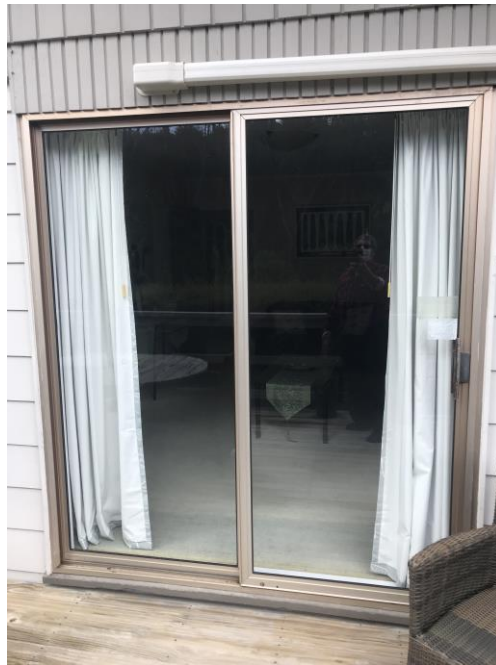
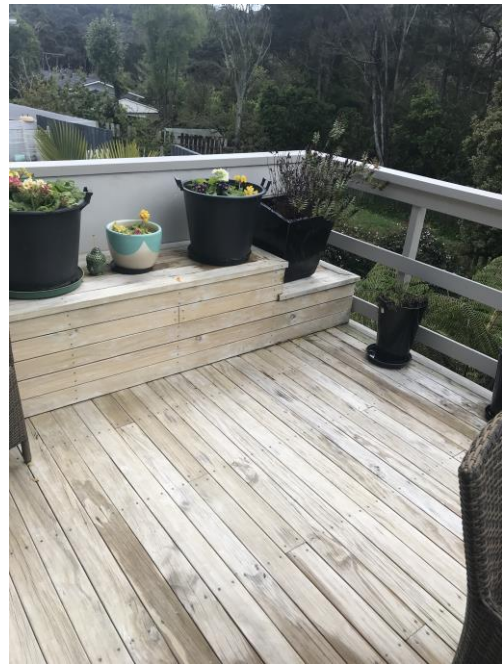
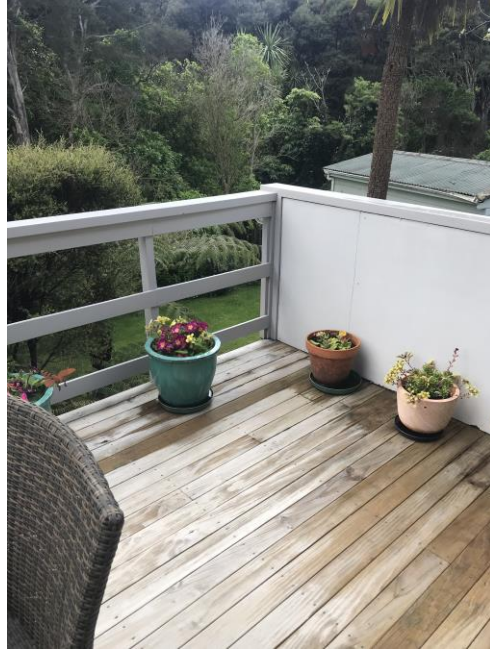
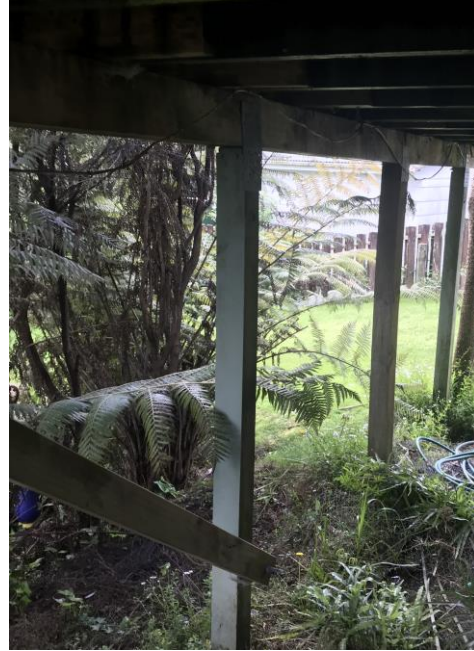
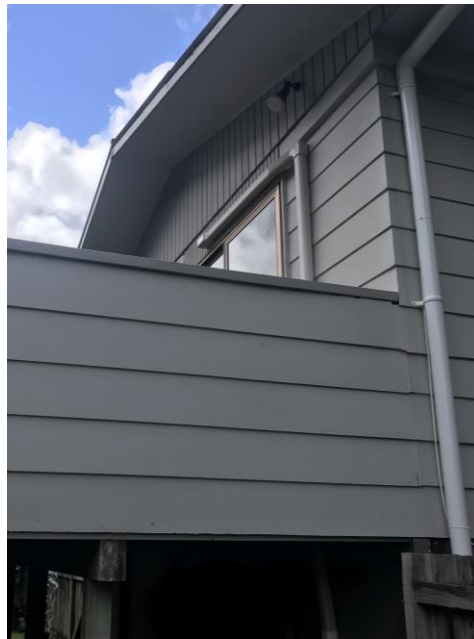
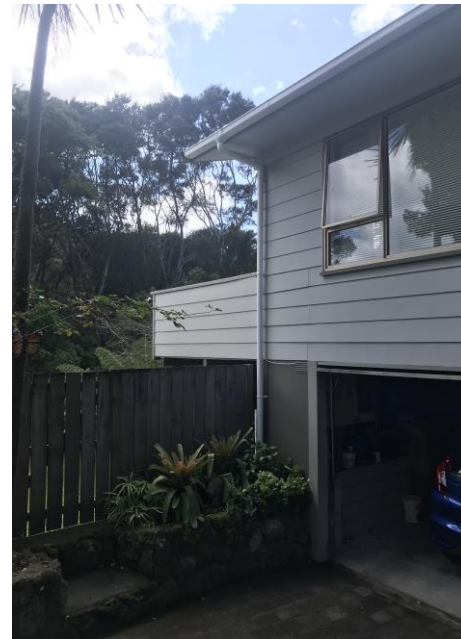
At the time of the initial construction, it appears that a deck was incorporated into the build. The deck was provided with a set of timber stairs that lead to the rear yard from the end of the deck. These stairs have subsequently been removed and the handrail and associated area of the deck made good. We have been advised that at the time of the stair removal the central bearer and supporting posts (foundations) were installed to take some spring (bounce) out of the deck.

The construction of the deck is typical of the construction method and requirements (material sizes and spacing) at the time. The deck has been provided with a safety barrier that also met with the requirements at the

time. The barrier has been enclosed at the ends with matching weatherboards to the dwelling and open rails to the face of the deck.

We are obliged as a matter of duty and care to mention that the height of what would have been considered to be a compliant barrier to the deck has been compromised at one end due to the construction of a seat (ledge). Consideration should be given to ensure that any risk of falling is reduced.

- 4.2 We recommend that some consideration is given to upgrade the barrier to the deck. What has been constructed met with the requirements at the time however the current Building Code views this style differently.
- 4.3 It is now a requirement to install smoke detectors (if not installed) within 3 meters of all sleeping rooms, please insure these are installed, tested regularly and maintained.
- 4.4 A building is deemed to be dangerous, if, in the normal course of events (excluding earthquakes) the building is likely to cause injury or death (whether by collapse or otherwise) to any persons in it, or any persons on other property, or damage to other property. In the event of fire, injury or death to any persons in the building or to person on other property is likely due to fire hazard or the occupancy of the building.
